Vehicle Safety Inspection Report

Stock 48
 VIN6 5094415
 Mileage 14195
 # Of Keys 2
 Exterior Inspected by:
Angel Ruiz

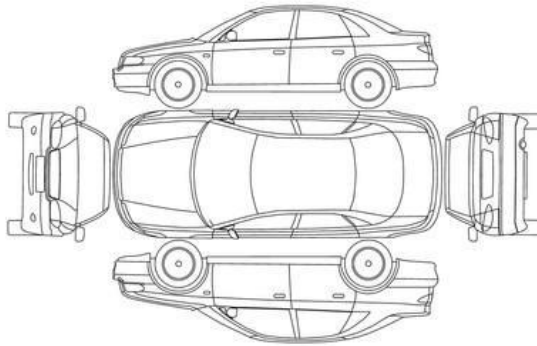
Mark any damage found on the vehicle exterior with "X"
